## On site validation of carbide coating for Pelton runners

# THE INTERNATIONAL JOURNAL ON HYDROPOWER & DAMS

Volume Twenty Three, Issue 4, 2016

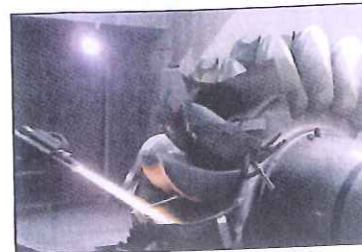
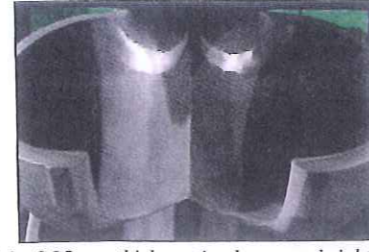
Left, the HVOF process during spraying of the 0.25 mm-thick coating layer; and right, protection from the coating at the end of the bucket.

HVOF processing consists of delivering of the material in the form of powder (within a size range of 5 to 50 microns) heated by a flame and projected by a supersonic gas jet towards a target (the surface of the component to be coated). As it travels to the target, the coating powder material takes the form of liquid or plastic droplets projected towards the target surface, where the splashing phenomenon and subsequent solidification are able to create a holding strength for the deposited droplets and the resulting coating.

The process which was used is known as CABOFLAM H654 (Flame Spray trademark). The chemical composition of the coating alloy was WC 86 per cent; Co 10 per cent; Cr 4 per cent. During the spraying process, the particle speed reached approximately 666 m/s; the temperature of the particles was about 1800°C, and of the base material, < 150°C.

Because of the high temperature and speed of the particles, as well as the consequent noise levels (> 120 dbA), the HVOF coating processing can only be carried out safely by robotized workstations operating within soundproof booths.

The complex shape of the buckets required elaborate programming for the robot, so as to achieve a uniform coating thickness.

More than 15 passes with different robot programmes were necessary to achieve an average coating thickness of 0.25 mm, with a standard deviation of 0.1 mm.

It was important to avoid the coating being deposited on the base, and this was achieved by masking the base material, as necessary, with a metallic shield. Also, deposition of the coating on the end of the bucket had to be avoided, so as to allow for adequate NDT monitoring of this critical area during operation.

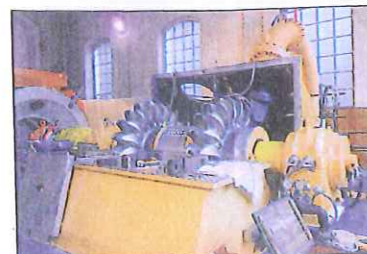
From left:  
The runner in service at the Curon plant in Italy.  
Inspection of the coated runner after 4500 hrs of operation.  
The coated runner after 6000 hrs of operation.
